MK-10 FET REPLACEMENT IN EARLY FT101/FT101B/FT277/FT277B

In an earlier post (<https://www.facebook.com/groups/759974814527577/permalink/995640837627639>) I highlighted a problem whereby the MK-10 FETs used by Yaesu had an in-built failure mechanism which means they will degrade and eventually fail and should be replaced.

This problem affects the FT101/FT277 (no suffix) and early models of the FT101B/FT277B that use the MK10 FET on various boards.

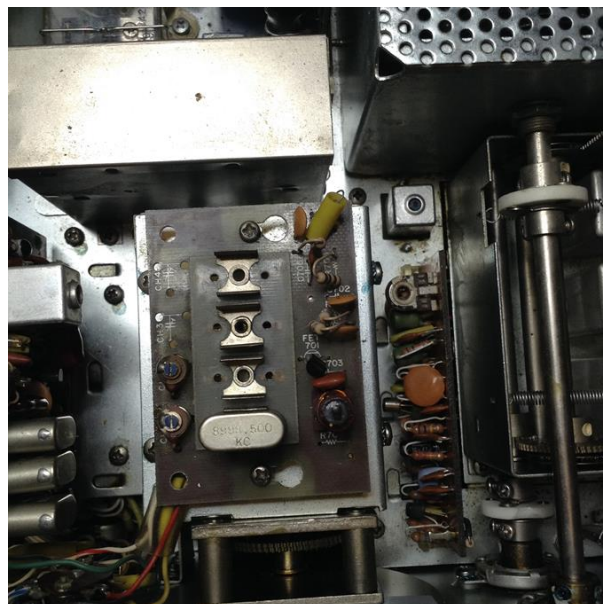
To see if your radio is affected, lift up the radio's top cover and check the Fix board (mounted on top of the VFO). It only has one transistor fitted and if it is a MK-10 (with blackened leads) then you should consider changing all of the affected boards. See list further down.

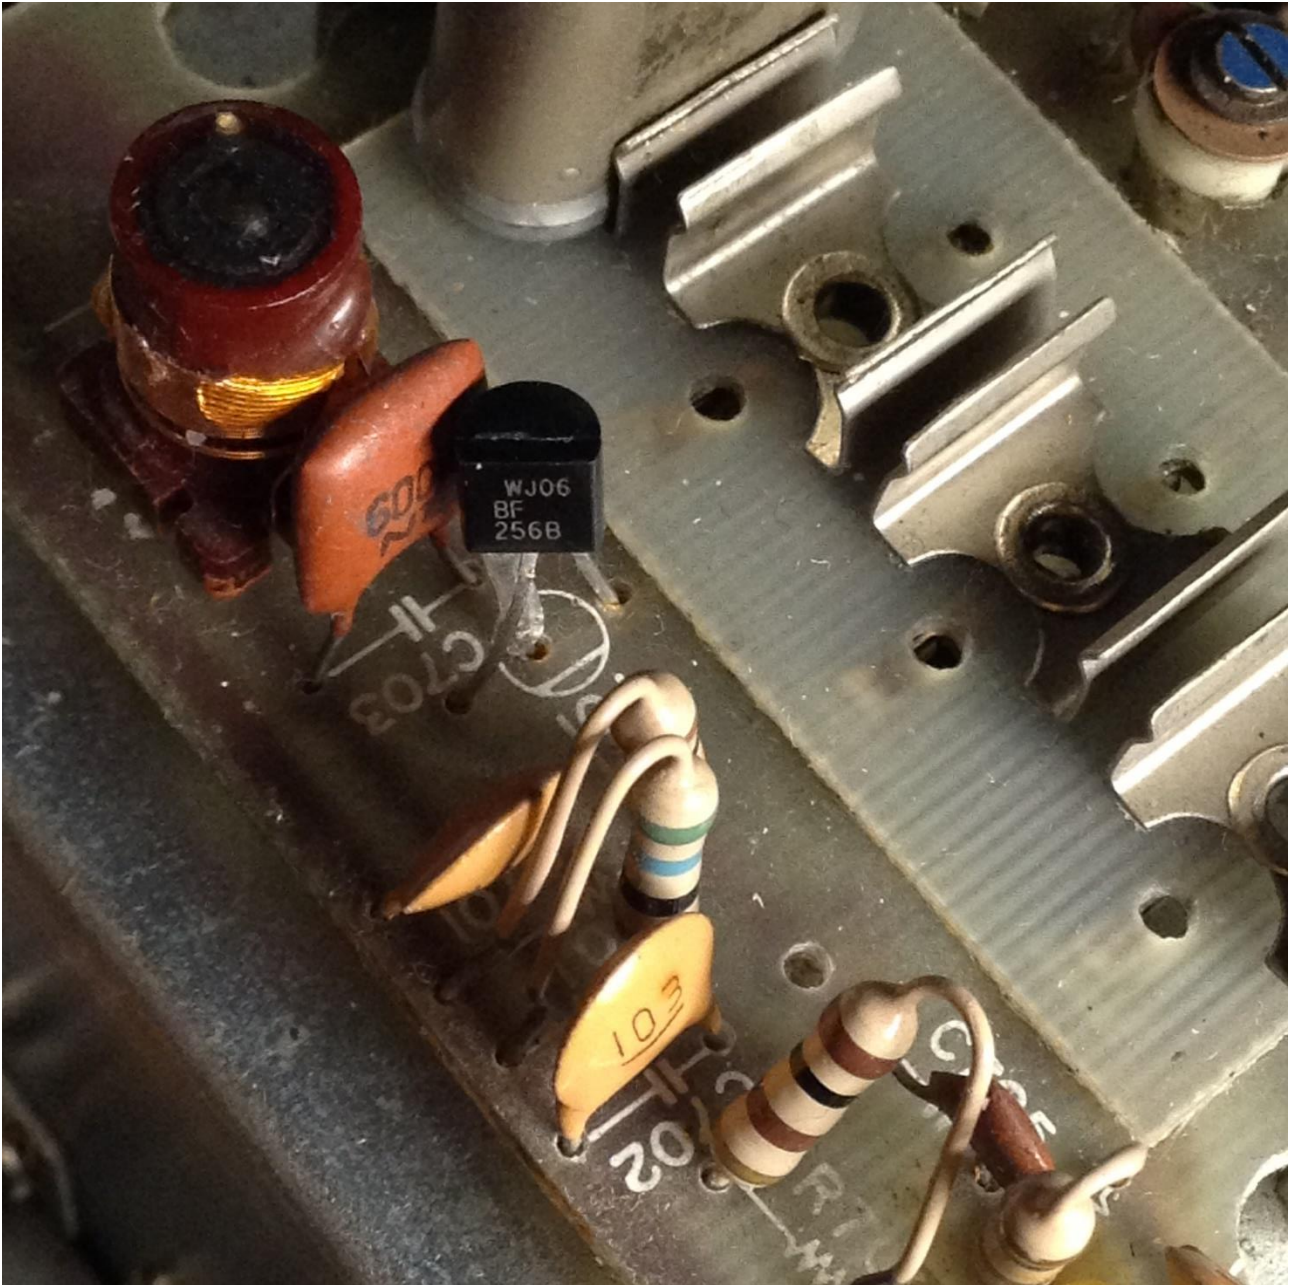
So, if replacing these MK-10 FETs with alternatives such as the BF256 just be aware of the different pinout and insulate/sleeve the legs as appropriate to fit on to the board. The photo shows the BF256B mounted on the Fix board with leads adjusted as necessary.

The BF256 pinouts are different to the MK-10 as shown in the attached diagrams.

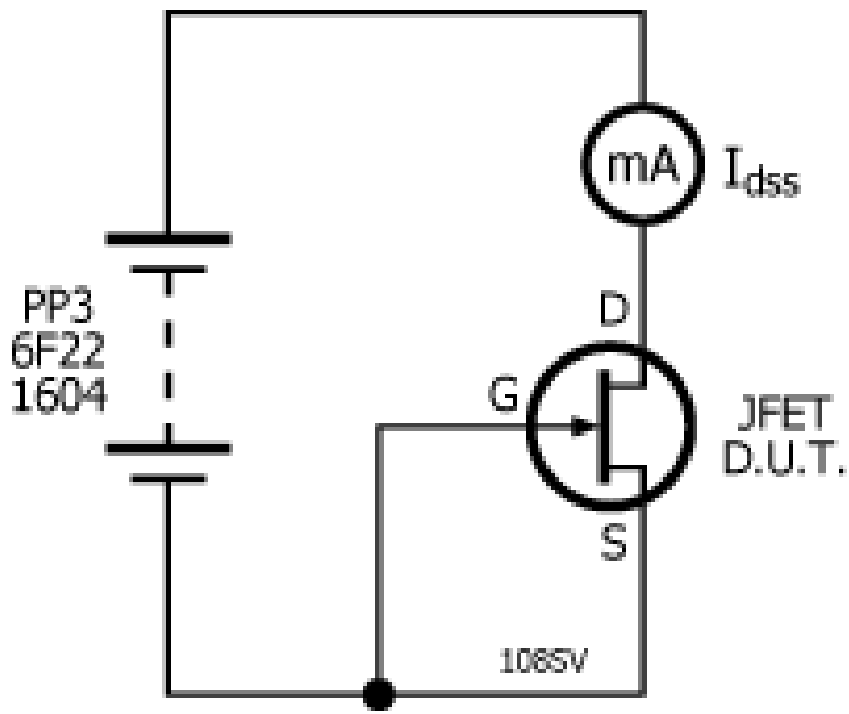
Selecting FETs – If you want to use FETs such as 2N3819 you should select them based on IDSS as previously mentioned. This can be simply done even if you do not have a transistor tester. You just need a 9V battery and a multimeter – see <https://stompville.co.uk/?p=112> for how to do this using the circuit below.

As I mentioned, another alternative would be the 2N3819 (also obsolete, but still available in places, and are pin for pin compatible with the MK-10), but these are not grouped into

IDSS bands and you would manually have to test and select devices depending on the measured values of IDSS. You might need a number of devices to get the right values.
