An ARTICLE on CARE OF YOUR 30L-1

The Care and Feeding of Your 30L-1 and Other Pertinent Trivia

de Bill Carns, N7OTQ/K0CXX

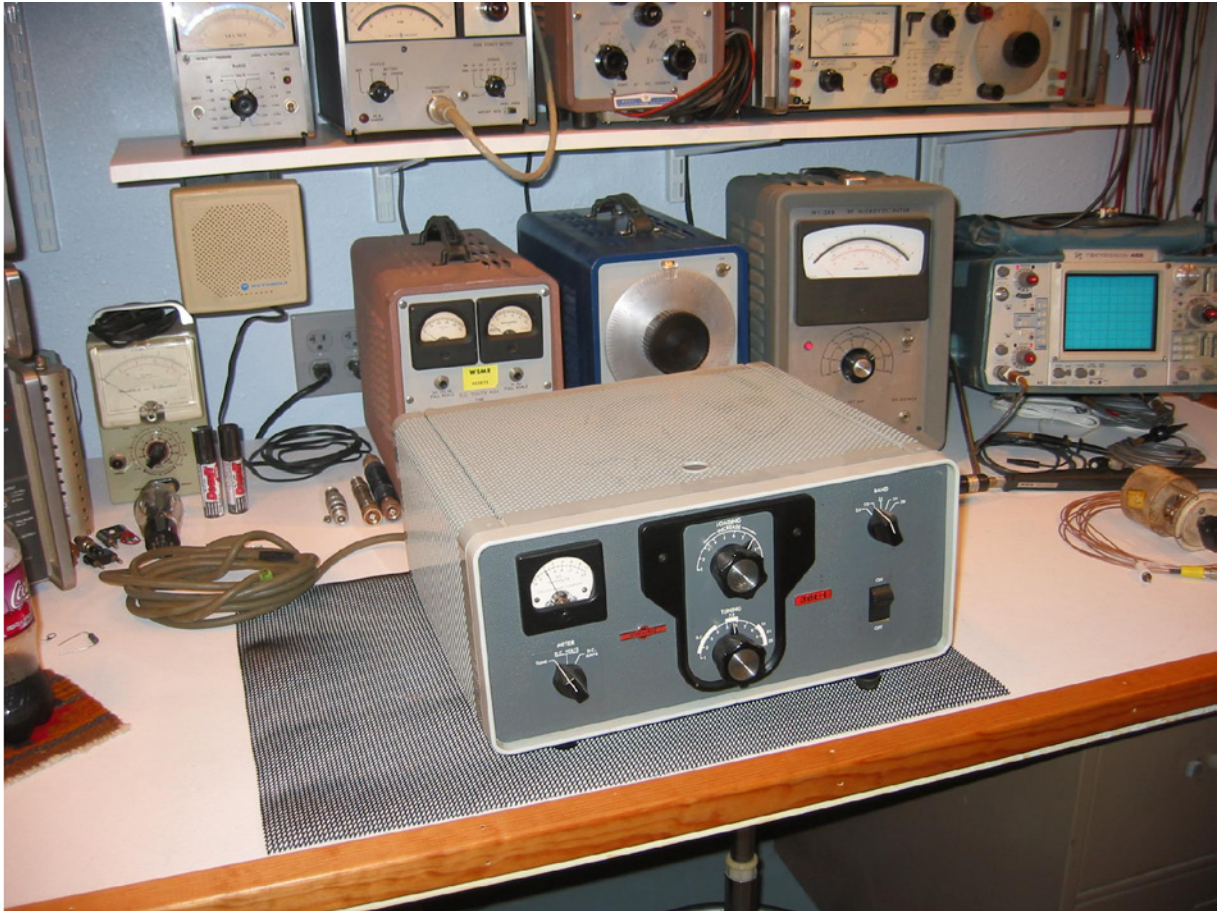
Figure 2. Oh Doctor, Serial Number 12770 is waiting in the exam room

But there seems to be something wrong with his foot - and he hasn't bathed for months.

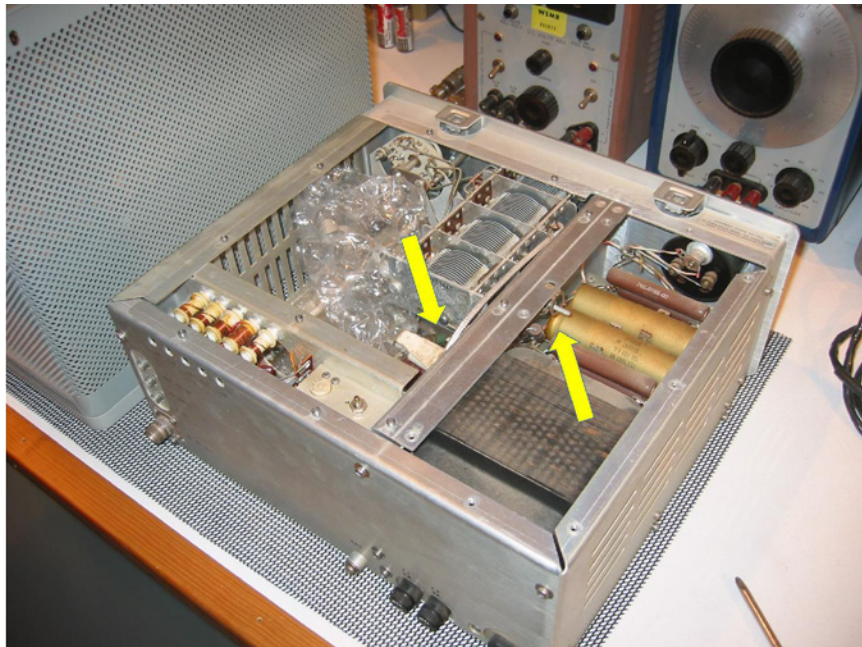
Remove the bottom and 2 top covers of the PA tube and HV compartments. Notice that there are spring loaded shorting interlocks that short the HV to ground when the covers are off. There are two on the top and one on the bottom. I say that because 30L-1s are often damaged by inexperienced repair efforts that involve running the RF amp with these covers off. First, try to never do that and if it is absolutely necessary and you are experienced at debugging HV equipment, then these shorting interlocks need to be defeated TEMPORARILY while the trouble shooting proceeds. This can be done by slipping a piece of heavy high voltage rated heat shrink over the screw in the center.

Figure 3. First surprise – No tubes. I forgot that Mister Thorough removed the tubes and padded the plate clips and braid before moving....Hmmmmmm, Time Out! ... and it is tube hunting time. With the current cost of 811As, read that PANIC time!

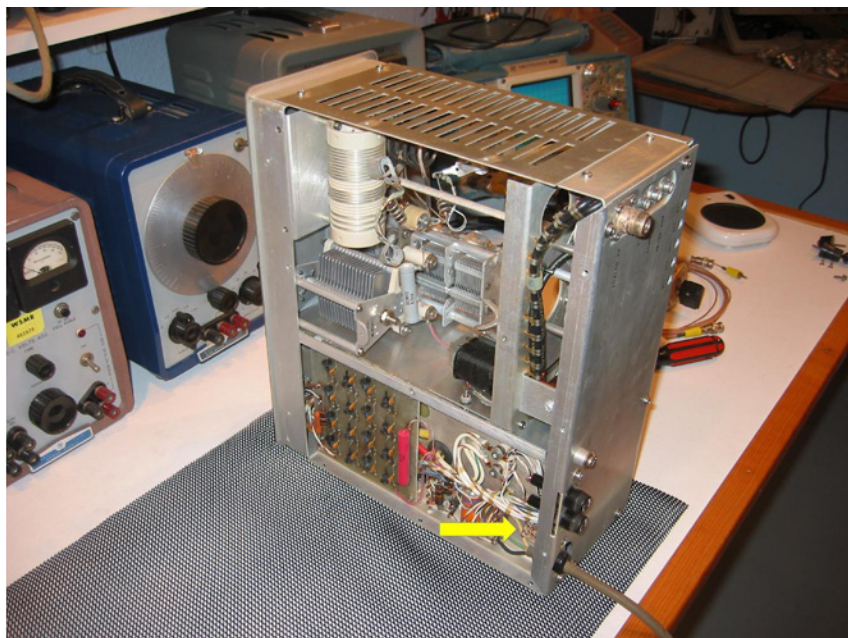
Figure 4. Bottom Cover off and note the bottom third high voltage interlock shown with the yellow arrow. (See the previous figure for the top two interlocks)

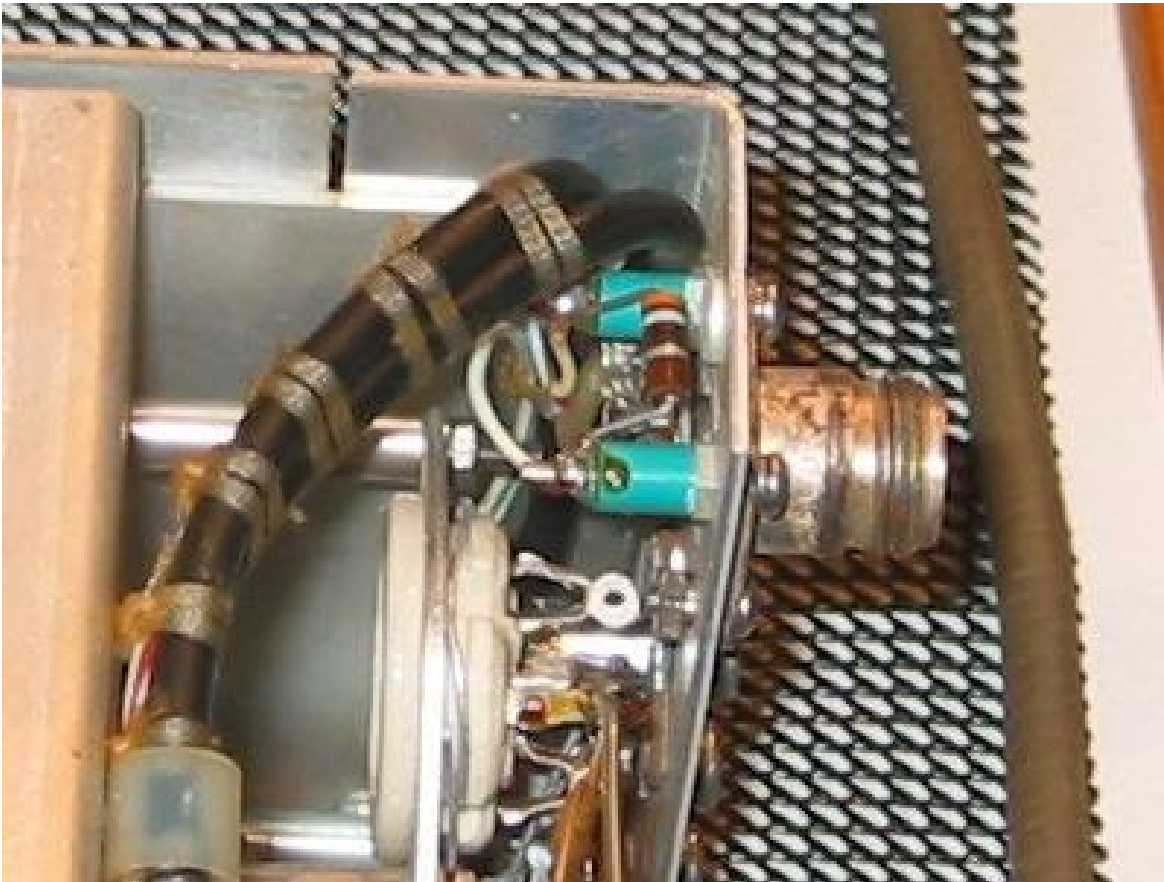
Figure 5. R28 Bias setting resistor (hiding behind the RF Antenna N Connector)

When the antenna relay is not pulled in, there is no current in R28.....So, why are folks upping the wattage when they find it blown? I think Collins engineers knew exactly what they were doing here and used a half watt because it was enough UNLESS the grid came up in voltage because of a tube short. In this case, what do you want to blow here? You can have damage to the relay and bias supply, or you can let R28 blow under this stress

and protect the relay. In fact, with the Bidirectional Clamp Diode protection mod recommended in this article, R28 will never see more than a half watt of dissipation. I leave this resistor at ½ watt. Now, finish this part by checking to see that R9 is 47 ohms and not 82 ohms. You may have to tweak this 47 ohm value (usually to a bit higher) to get the correct 110 (+/- 5) mA idle current with today's higher line voltage.

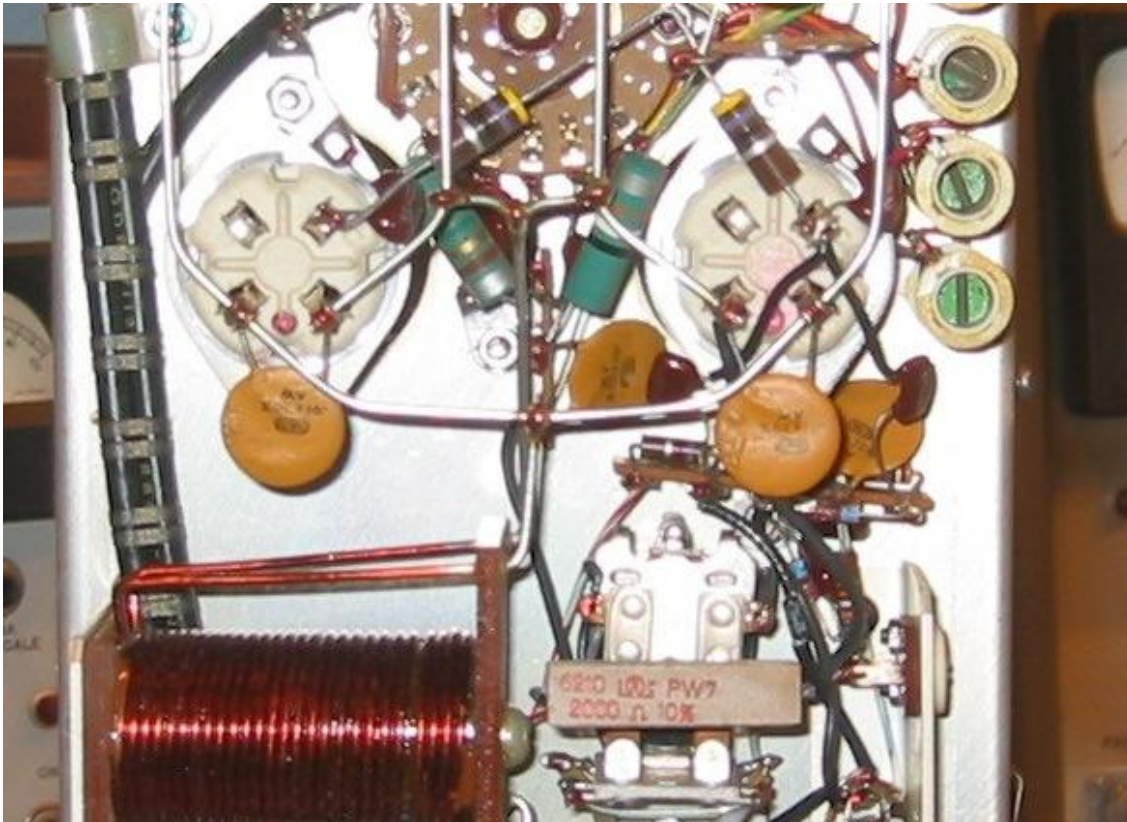
Now for “The exception that makes the rule!” While we are in the back end of the amp, I am going to make the one and only (non-destructive, completely reversible) mod that I recommend (No, insist on) in a 30L-1. Locate C2, a disc ceramic 0.01 mfd cap that is just to the right of the 47 ohm star connection of grid bias through the RF choke L3. Physically, C2 is on a three lug (center ground) terminal strip that is located just to the right of the tube sockets looking at the back of the amp while it is lying on its side. C2 lies flat against the chassis going from the right outside terminal to the center ground.

Figure 6. C2 shown to the right bottom of the terminal strip before Bidirectional Clamp Diode Install

Install a bidirectional Clamp Diode rated at 20 amps 180 volts (min). It will install in the lower position on the terminal strip flat to the chassis. It should be carefully non-destructively tacked across the terminals supporting C2. Position it in that open space to the left of the terminal strip and just below the green choke in Figure 6 shown above. Now, in case of a plate to grid short in one of the 811As (not uncommon), the Transzorb (or surge suppressor) will shunt the plate voltage to ground and save the bias supply - including the transformer winding - and also save the relay. Good Job! It will possibly die in the process and will short to ground which hurts nothing and then can be easily and non-destructively replaced. As they say at Am Ex, Don't leave home without it.

Note: This mod is also highly recommended by Dennis Brothers - who is still an authorized Collins repair station. Dennis used to run the internal repair facility at Collins Radio in Cedar Rapids. Obtain **Part # 625-1.5KE180CA-E3, Mouser pg. 596, Cat. # 643**

Note: The Bi-Directional clamp, or TransZorb, that is currently recommended for installation in the 30L-1 is much different in appearance than the original MOV shown in the earlier version of this article, but installation is the same and is not sensitive to polarity since it is "Bi-Directional". This Vishay part looks more like a diode.
